The
New  
Standard.

Company Overview

How FLOWASSIST Was Born

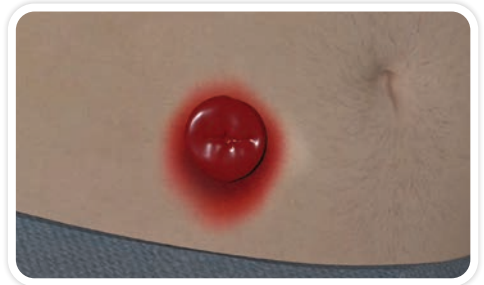
This results in a **vicious cycle** of leakage and worsening skin condition.

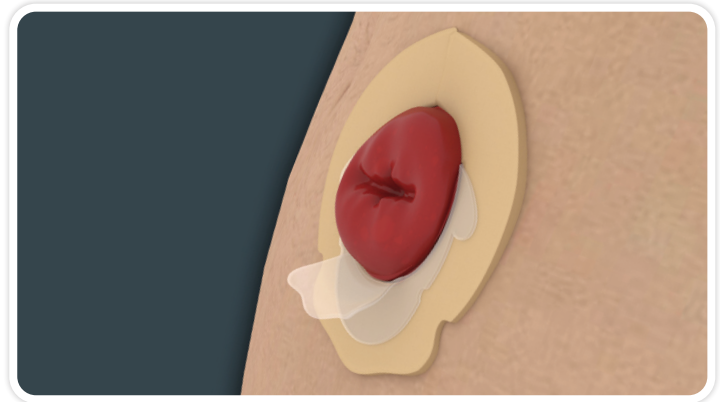
Directs corrosive stoma output away from the skin and into the pouch.

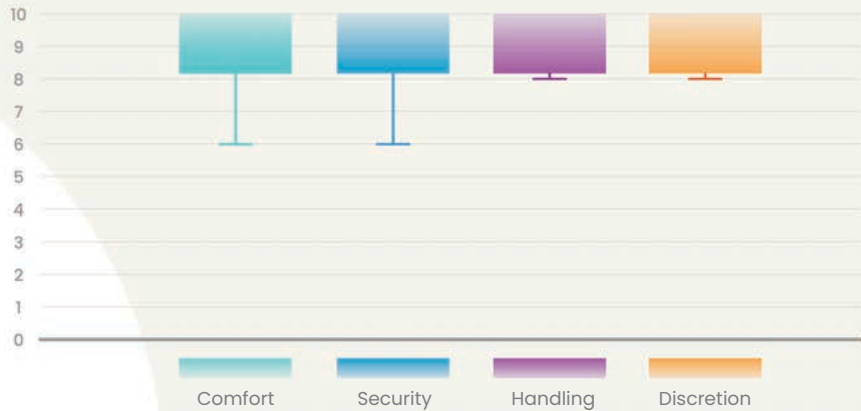
Median User-Experience
Rating at 6 Weeks
(1-10)

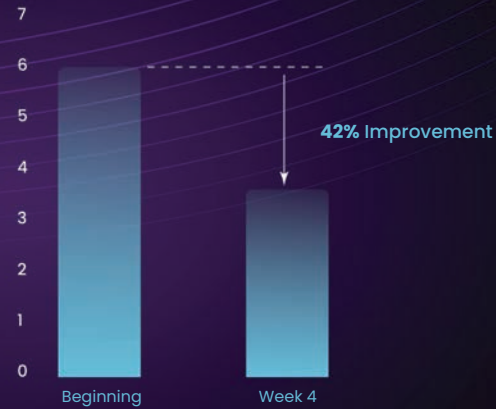
DET Score

Average Skin Complication Level (1-15)
Measured Using the Ostomy Skin Tool
(DET Score)

Among the participants, switching to the FLOWASSIST Seal resulted in statistically significant improvement in peristomal skin health. The average skin damage (DET) score started at 6.21 ± 3.63 at time T=0 and decreased to 3.63 ± 3.56 at time T=4 weeks ($p < 0.001$; Cohen's $D = 1.09$). The average scores for ease of application, ease of removal and comfort of the novel barrier ring were all greater than 4.5 out of 5 (5 being the most positive experience) and an average score of 4 out of 5 was given for its effectiveness at protecting the peristomal skin.

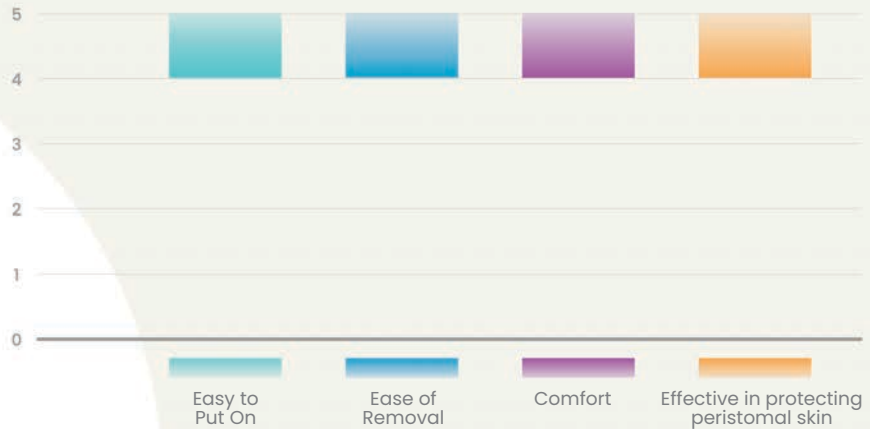
Median User-Experience
Rating at 4 Weeks
(1-5)
