Game Changer: Use of an Innovative Spouted Hydrocolloid Ostomy Barrier Seal to Manage a High Output Ileostomy

Keisha McElveen-Edmonds MS, BSN, RN, CWON   Baltimore VA Medical Center Baltimore, Maryland

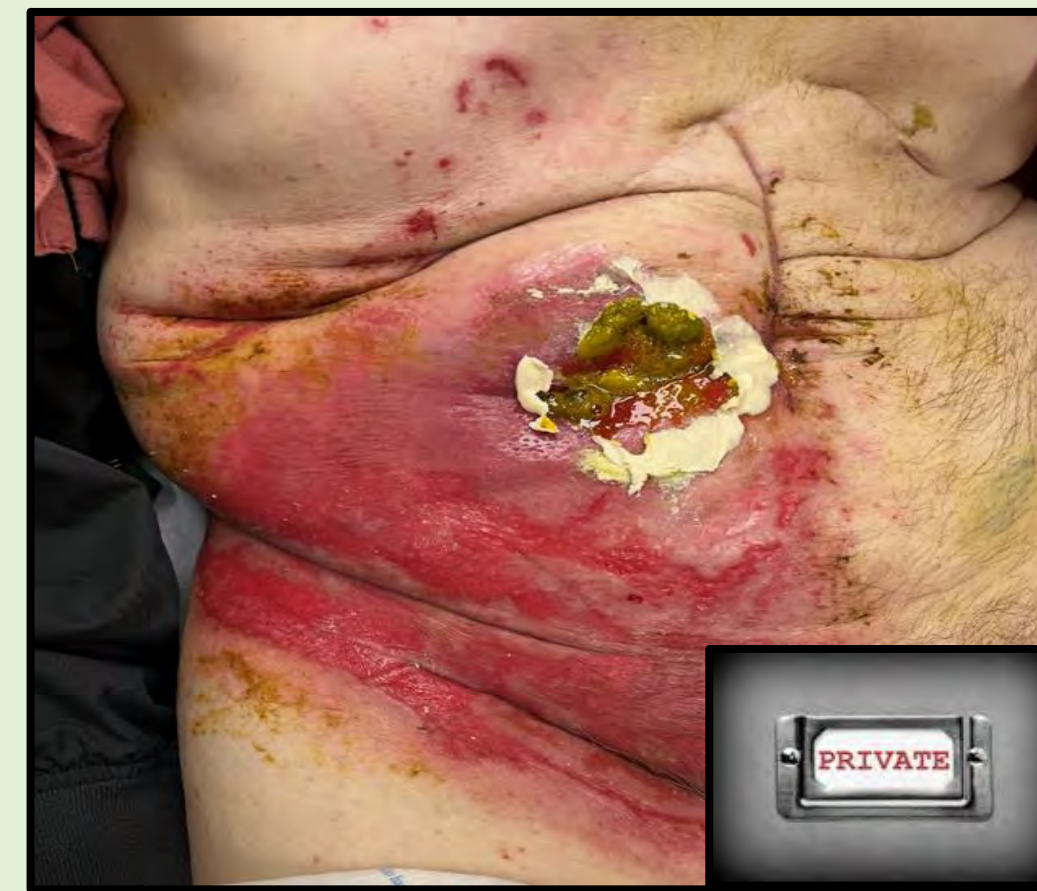
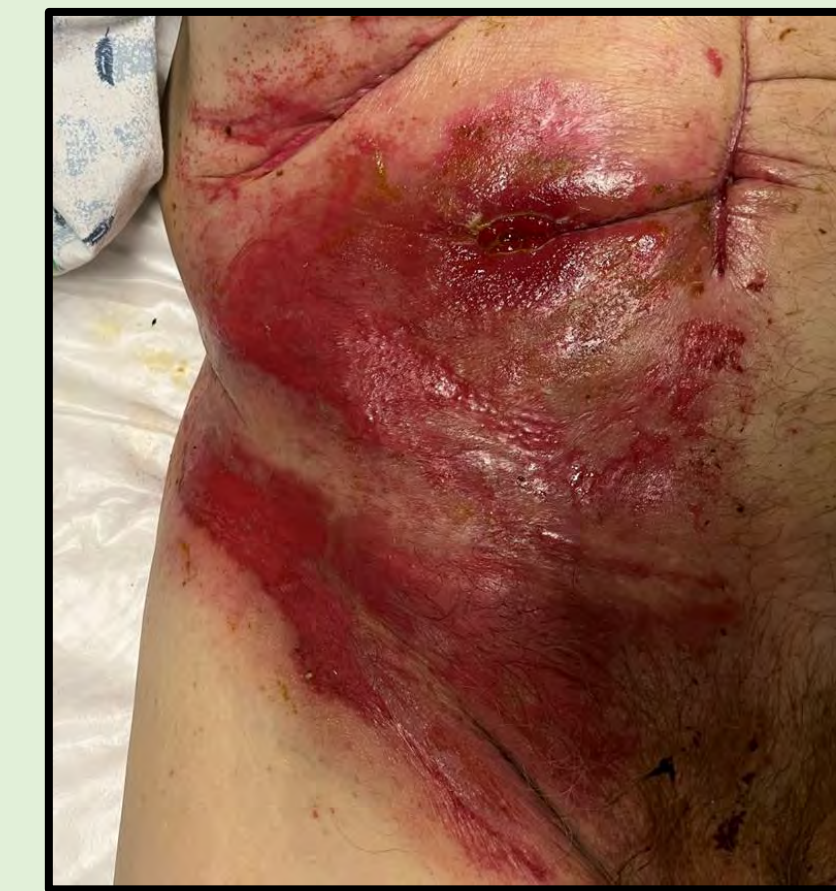
Day 1

HPI: The patient had several weeks of extreme effluent leakage from his high-output fluidic stoma with the inability to maintain an adequate pouch seal. He was provided with an urgent appointment in the General Surgery clinic.

A spouted hydrocolloid ostomy barrier ring in conjunction with a convex one-piece appliance was used to direct ostomy effluent from a retracted stoma with a downward and slanted os. The flow assist technology of the spouted barrier seal optimized drainage flow directly into the appliance instead of between the barrier and seal or beneath the barrier alone. Photographs were taken during the initial assessment and application and on subsequent weekly appliance changes, to determine efficacy in prevention of leakage, reduction in pouch change frequency while improving skin health.

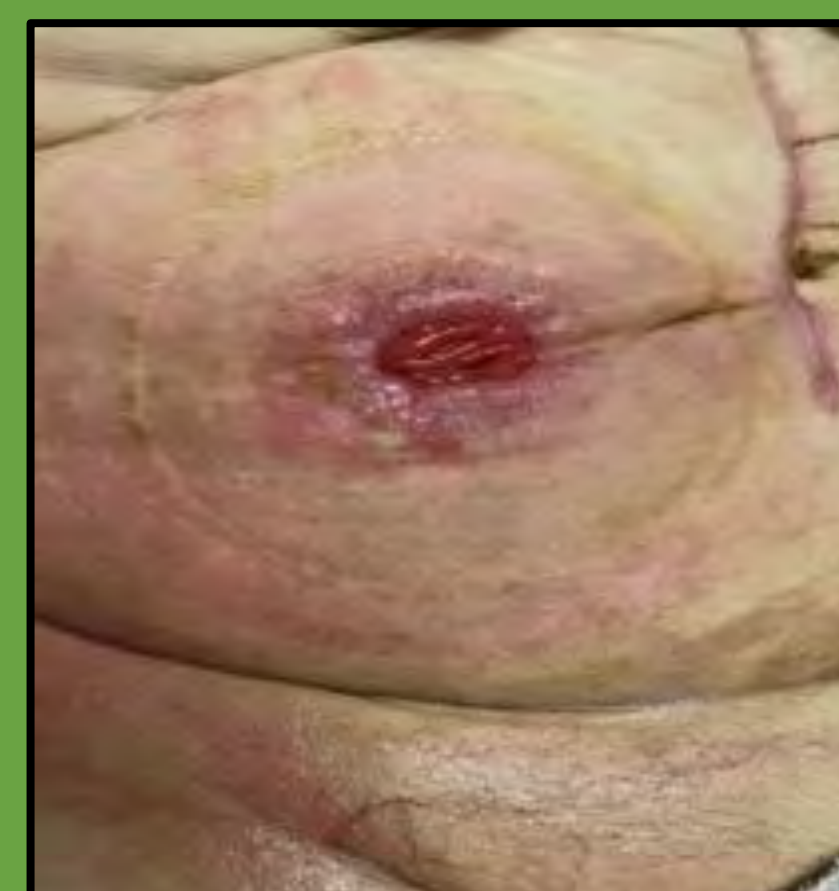
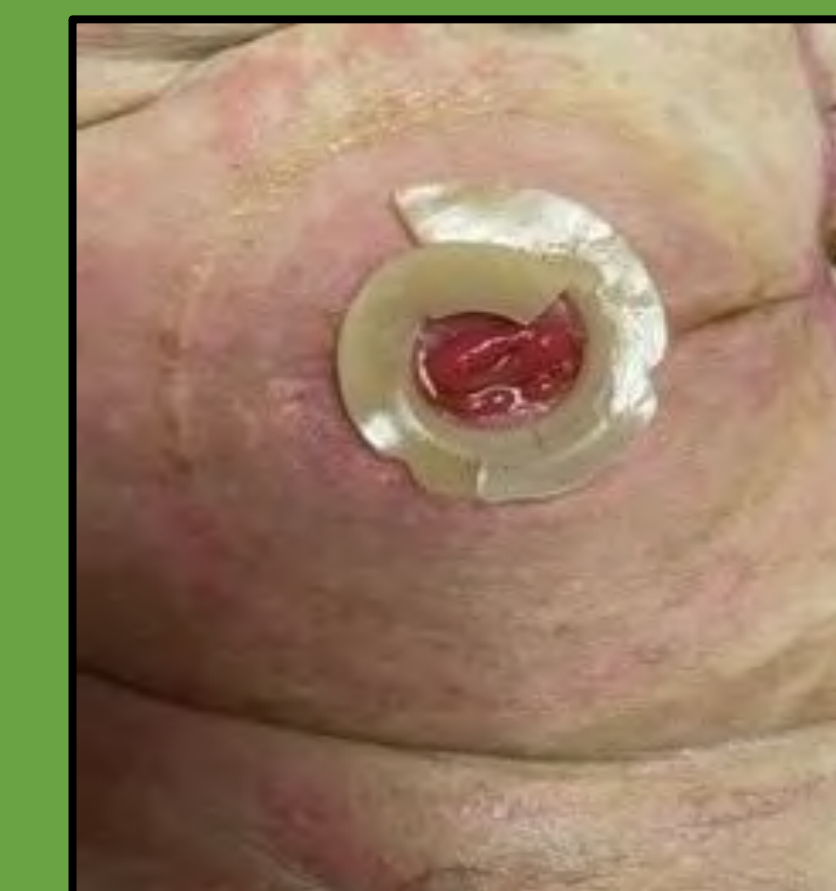
Week 4

The **spouted hydrocolloid barrier ring** provided significant benefits by **protecting the skin while directing the effluent flow** into the pouch. **Pouch wear time increased to six days with no further leaks**; skin was able to be treated and skin health improved tremendously. The spouted hydrocolloid was crucial for care management of this challenging case. It was used for 4 weeks with each pouch change until the Vet was hemodynamically stable and returned to the OR for ostomy takedown.
